Keeyask Transmission Project **Environmental Effects Monitoring Plan** Annual Report

Prepared by:
Manitoba Hydro
Winnipeg, Manitoba
June 2017

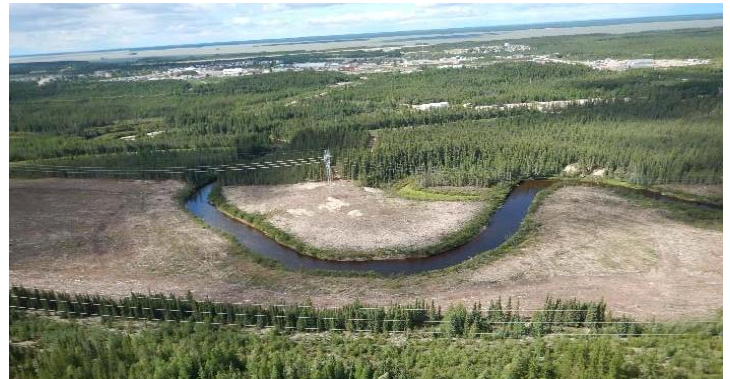
Photo 1: Keeyask Transmission Project is located south of Gillam, MB. GOT lines 2 and 3 are scheduled for construction in 2017/18.

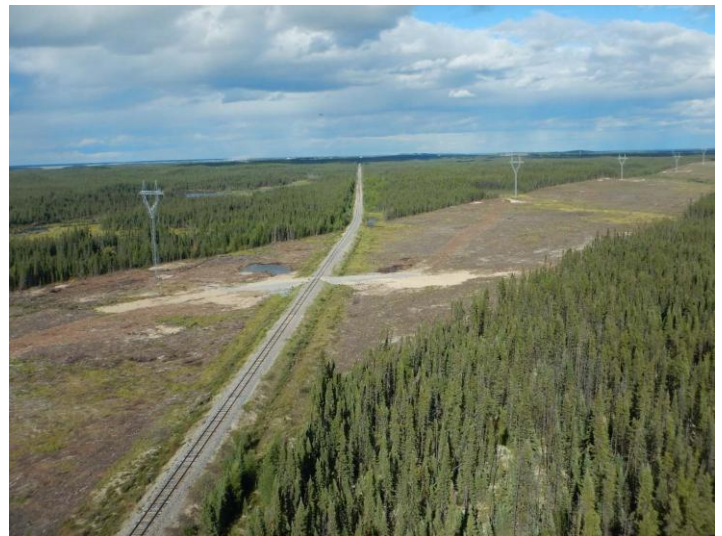
Photo 2: Keeyask Transmission Project traverses the Hudson Bay Railway.

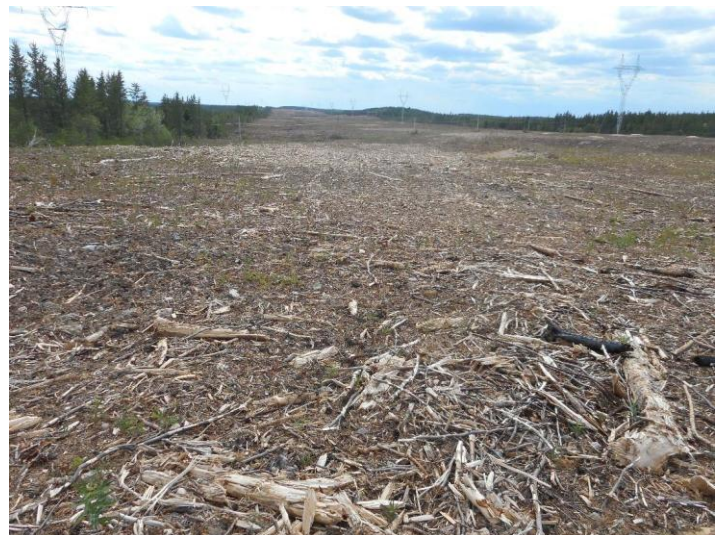
Photo 3: The clearing process minimized exposure of soil, preventing the encroachment of invasive species.

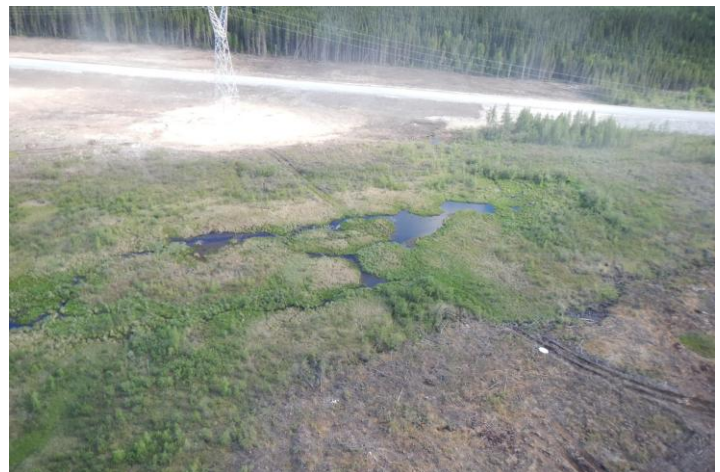
As predicted in the EA, Project effects on stream crossings were minor. Of the 41 watercourse sites assessed in 2106, construction at all but one stream crossings was compliant with prescribed mitigation. This site (Photo 4) showed evidence of minor damage to due to vehicle traffic.

Photo 4: Evidence of minor damage due to vehicle traffic across a stream crossing.

Due to the natural revegetation of damaged locations, no further remediation is required.

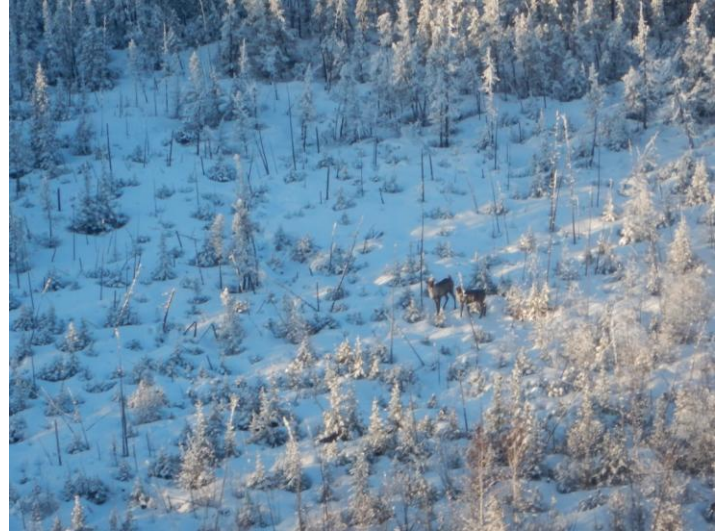
Photo 5: Summer resident caribou identified south of the Project area in December 2016.

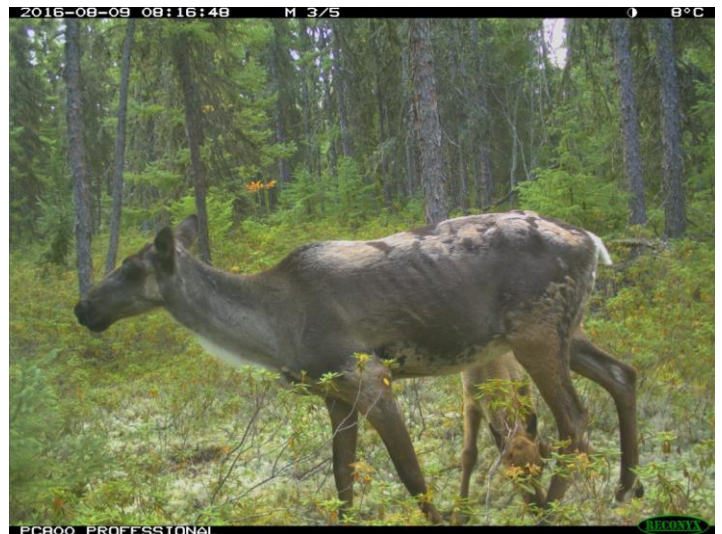
Photo 6: Summer resident caribou with calf on an island in Stephens Lake in August 2016.

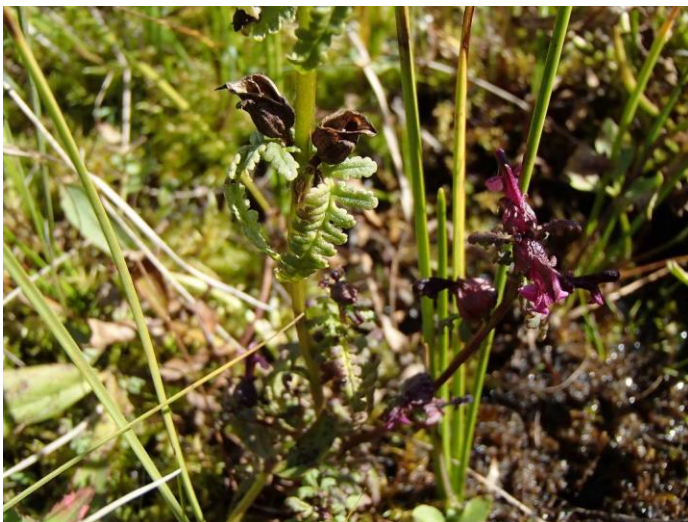
As predicted in the EA, Project construction had very low effects on the four known priority plant locations in the Project area. Muskeg lousewort (*Pedicularis macrodonta*) is the only rare plant known to occur in the Project area. Healthy, living muskeg lousewort plants were found at all four priority plant locations, post construction.

Photo 7: A muskeg lousewort plant.

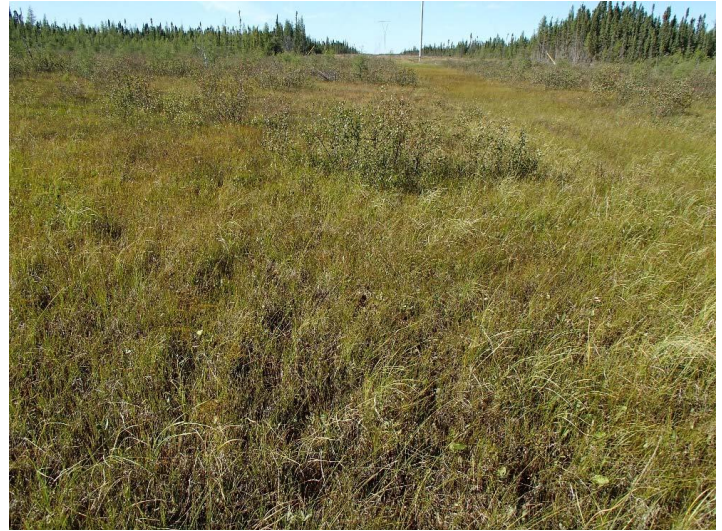
Photo 8: Horizontal fen supporting a large patch of muskeg lousewort within the ROW.

The implementation of mitigation recommendations outlined in the construction Environmental Protection Plan, were effective at protecting these environmentally sensitive sites.

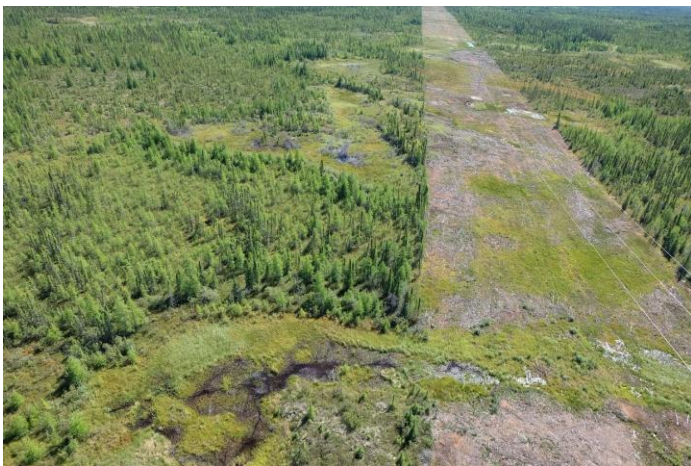
Photo 9: Minimal vegetation clearing was conducted near wetlands.

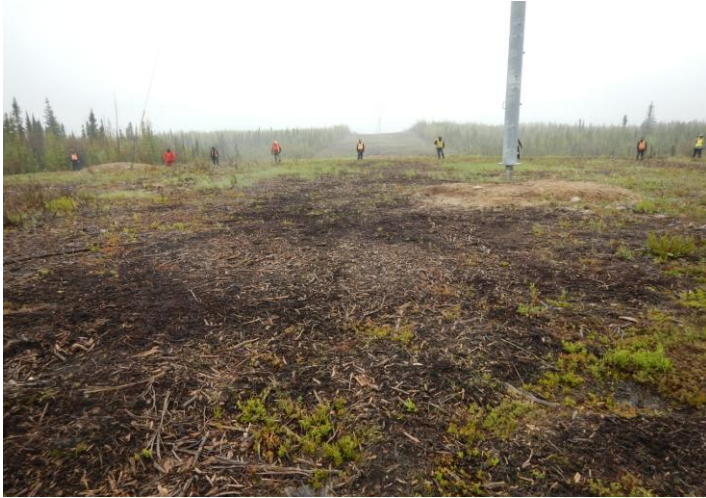
As predicted in the EA, the installation of power line sentry and spiral bird diverters on the Keeyask transmission lines at environmentally sensitive sites appears to have been successful at protecting birds from collisions. After correcting for searcher efficiency, scavenger removal bias, and habitat bias, minimum estimated collision mortality was 10.80 birds/km in the late breeding bird season and 10.32 birds/km in the fall migration period. These bird-wire collision mortality estimates are lower than rates reported in the literature.

Photo 10: Survey personnel searching for bird-wire collisions at environmentally sensitive sites.

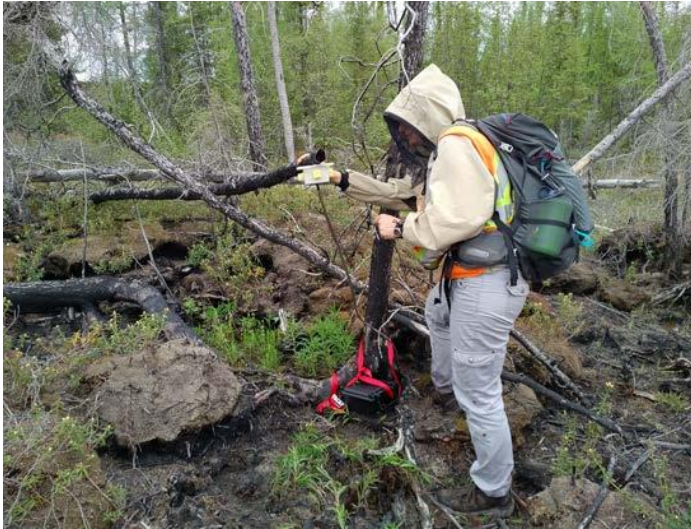
Manitoba Hydro is working cooperatively with the Keeyask Hydroelectric Limited Partnership (KHLP) to jointly study Project effects on bird species of conservation concern. Due to the long term nature of this study, surveys done in 2016/17 were focused on verification of study design and passive field recording units. Field crews located about 50 territories of olive-sided flycatcher (*Contopus cooperi*) and rusty blackbird (*Euphagus carolinus*) in early June, 2016. Of these, 26 rusty blackbird and 21 olive-sided flycatcher territories were mapped. 119 audio recorders were placed in the mapped territories at 32 disturbance sites from June 12 to 29, 2016. This information will serve to allow the development of a multi-year monitoring program. Survey support was provided by members of the Keeyask Cree Nations, including Tataskweyak, War Lake, York Factory and Fox Lake Cree Nations.

Photo 11: Installation of passive audio recorders to monitor bird species of conservation concern.

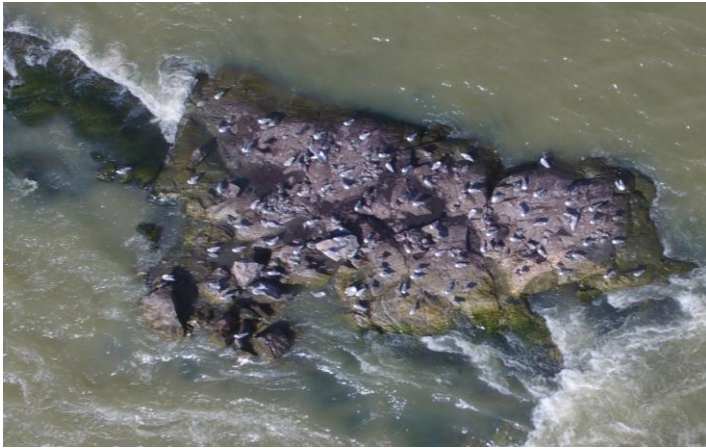
The productivity of ring-billed gulls (*Larus delawarensis*), the most common gull in the Keeyask area, was found to be within published ranges from other study locations.

Photo 12: An island in the Keeyask rapids supporting Ring-billed gulls and chicks.

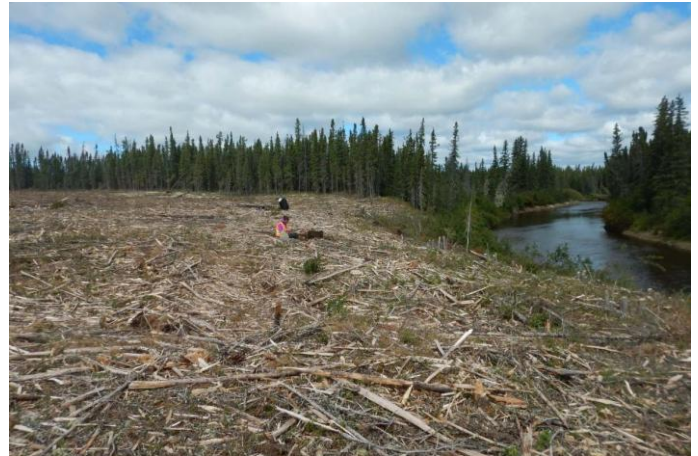
Photo 13: Shovel testing for heritage resources near the Kettle River.
