Manitoba-Minnesota Transmission Project

Post-Construction Environmental Monitoring Report

Certificate EC-059

January 31, 2023

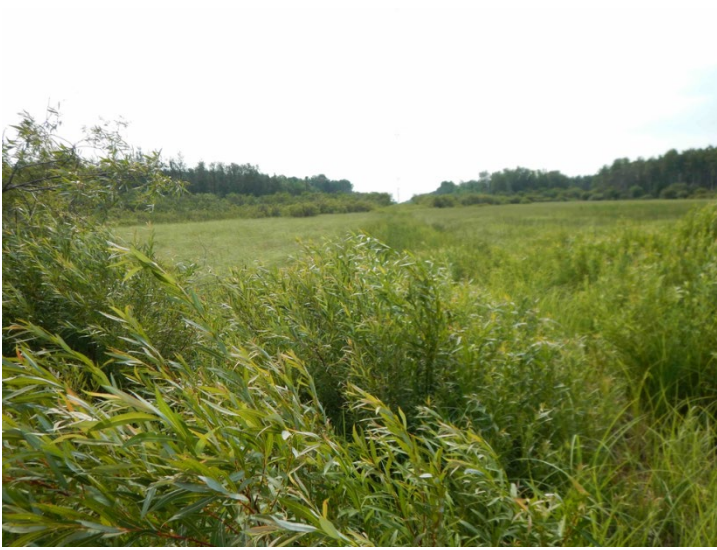
Photo 1 Wetland monitoring site along the MMTP right of way.

Wetland surveys were conducted by qualified contractors who evaluated aerial photography and conducted site inspections on pre-selected long-term monitoring sites on July 18-21st, 2021 (Photos 1, 2). A summary of the results can be found below. Detailed description of methods, maps, and results can be found in the vegetation technical report included in Appendix A.

Mitigation measures during vegetation clearing and construction appear to have minimized surface disturbance and have been effective. No major disturbances were noted at any wetland sites, and surface soils appeared relatively undisturbed without major rutting observed. Low water levels due to ongoing regional drought conditions were noted.

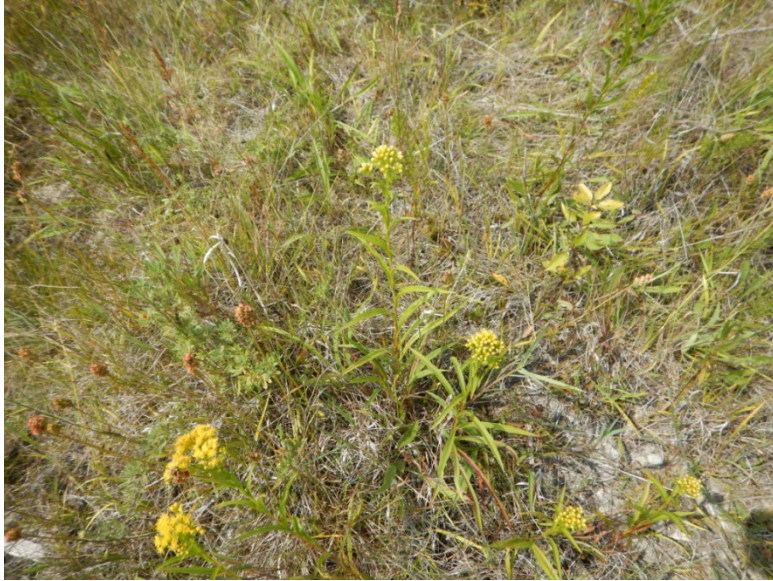
Photo 3 Riddell's goldenrod (*Solidago riddellii*) is a threatened species that was incidentally observed post-construction on the right of way.

Surveys for rare plants concluded in 2020 and were reported in the 2020 MMTP post-construction monitoring report. No further action or mitigation was identified. However, incidental observations of rare plants were recorded during wetland, invasive plant and golden-winged warbler habitat surveys in 2021. One rare plant was observed during project monitoring in 2021, listed under Manitoba's *The Endangered Species and Ecosystems Act* (ESEA) and the federal *Species at Risk Act* (SARA) (Photo 3). Riddell's goldenrod (*Solidago riddellii*) was incidentally observed at a site with approximately 45 plants recorded. This site was reported to the Province of Manitoba Conservation Data Centre and new mitigation measures were added to the MMTP operational environmental protection plan.

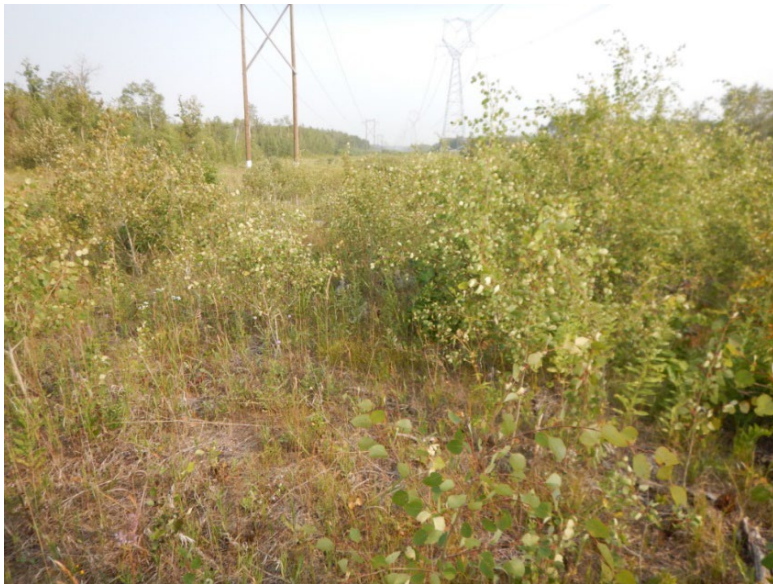
Photo 4 Surveys in 2021 showed an increased cover of vegetation in the tall shrub stratum.

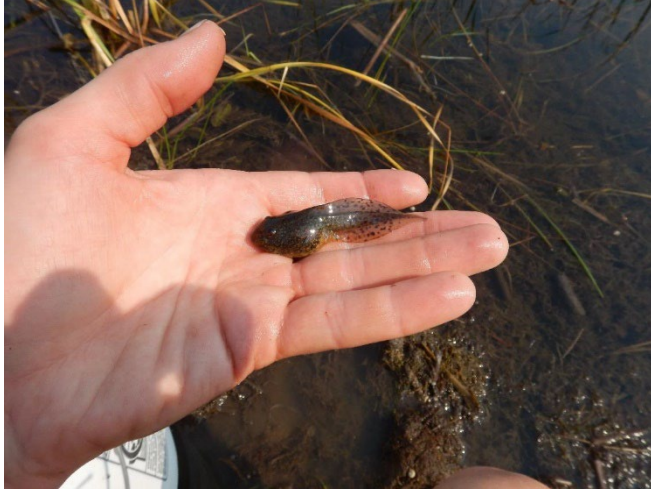
Photo 5 Northern leopard frog (*Lithobates pipiens*) tadpole observed on the right of way.

Wetland amphibian surveys were conducted by qualified contractors at preselected sites on May 10-16th, July 9-13th, and October 12-14th, 2021 (Photos 5 and 6). Sixteen sites were surveyed and assessed for species presence and water quality parameters. A summary of the results can be found below. Detailed description of methods, maps, and results of the wetland amphibian survey can be found in Appendix B.

As predicted in the EIS, there did not appear to be any unanticipated project effects on northern leopard frogs, eastern tiger salamanders, or water quality within or adjacent to the Project in 2021. Amphibian species continue to be present and water quality at sites was similar during pre-construction and post-construction surveys. Dry regional conditions and low water levels in 2021 prevented water quality sampling at some sites.

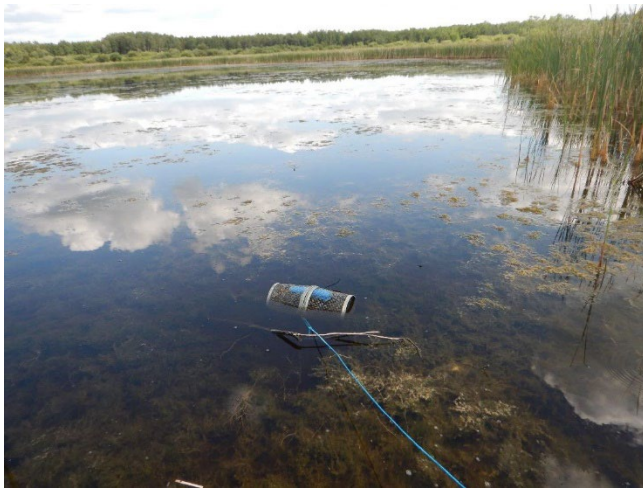
Photo 6 Funnel trap deployed along the right of way.

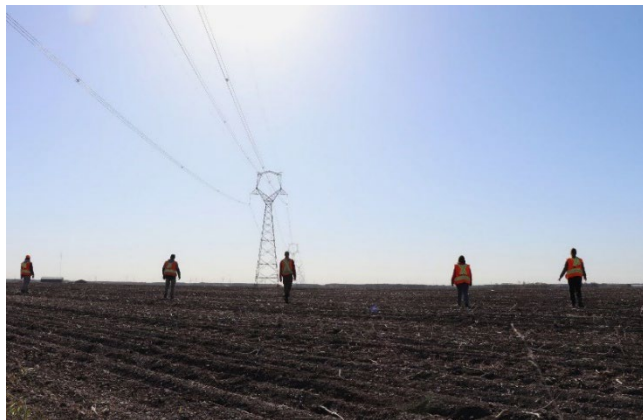
Photo 7 Bird wire collision surveys were conducted along MMTP.

Bird-wire collision surveys using standardized methods were conducted by qualified contractors at sixteen pre-selected sites in May 11-13th, June 1-10th, and August 23-September 2nd, 2021 (Photos 7 and 8). A summary of the results can be found below. Detailed description of methods, maps, and results of the bird-collision survey can be found in Appendix C.

As predicted in the EIS, some bird collisions were observed in post-construction phase of the Project. Estimated collision mortality rates were calculated based on number of collisions detected on surveyed transects, while accounting for site specific variables. Collision rates appear to be higher in comparison to other studies, but may be a result of dense vegetation conditions, which despite a robust effort, led to relatively low searcher efficiency metrics in 2021. Despite mitigation, two mortalities of species of conservation concern (a western grebe and rusty blackbird) were identified at spans marked with bird diverters. Further surveys will be conducted in 2022.

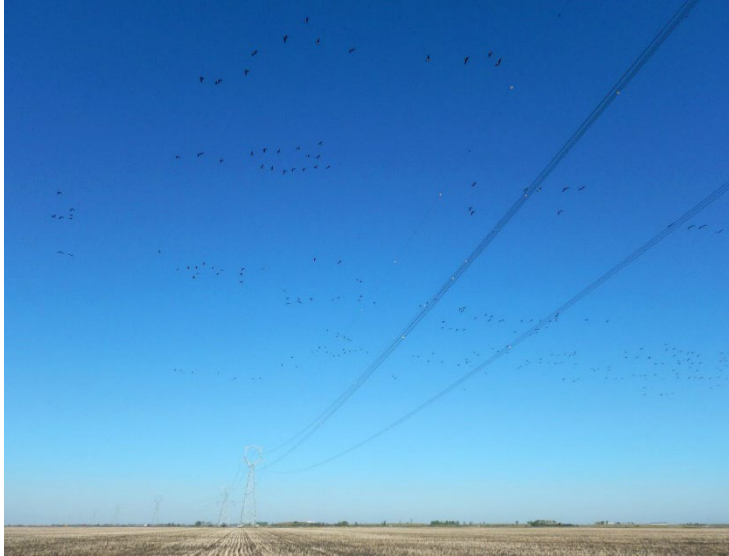
Photo 8 Waterfowl observed flying over MMTP.

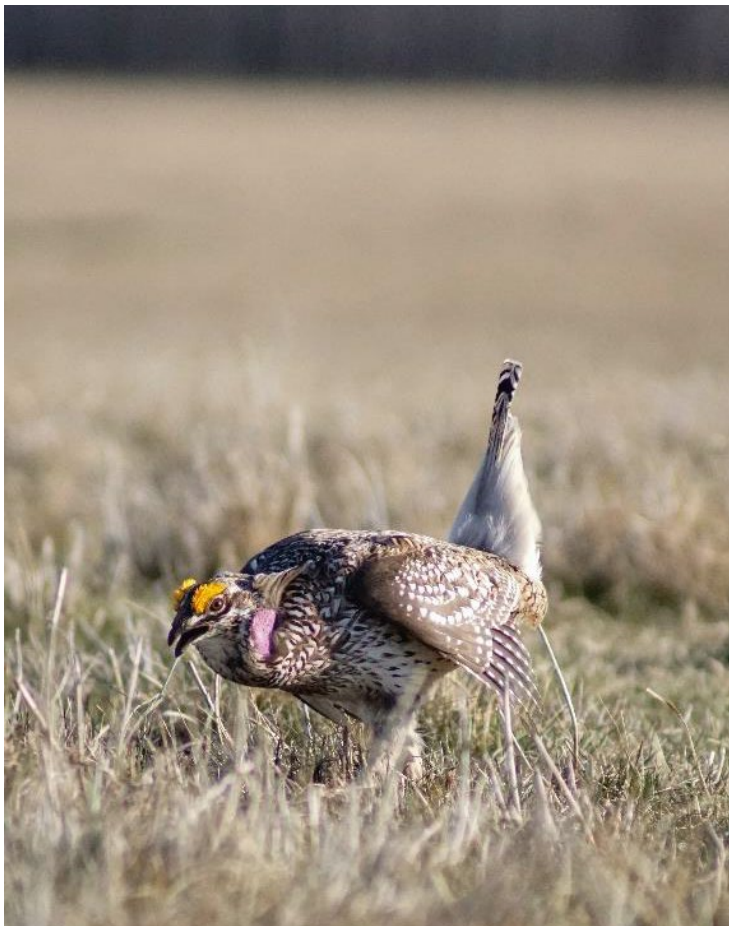
Photo 9 A sharp-tailed grouse (*Tympanuchus phasianellus*) lek near MMTP.

Sharp-tailed grouse lek surveys using standardized avian and camera trap methods were conducted by qualified contractors at seventy-four identified sites from April 16-May 4th, 2021 (Photo 9). A summary of the results can be found below. Detailed description of methods, maps, and results of the sharp-tailed grouse lek survey can be found in the technical report included in Appendix D.

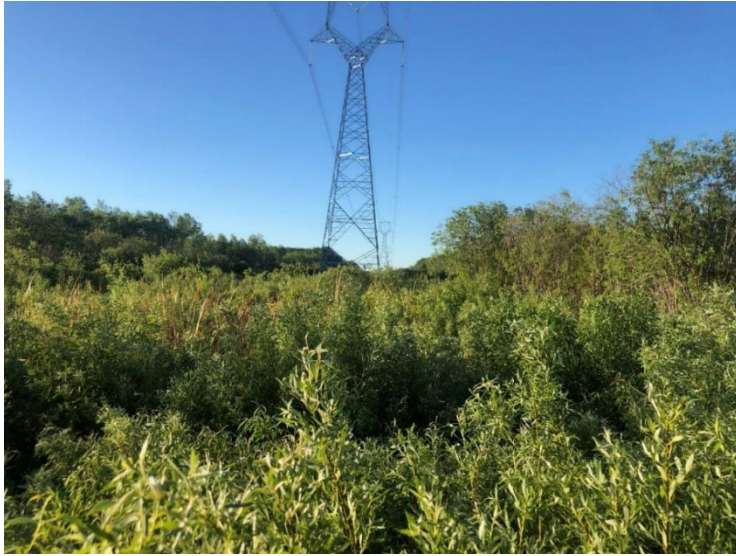
Photo 10 A golden-winged warbler (*Vermivora chrysoptera*) monitoring site in 2021.

Bird species of conservation concern surveys were conducted by qualified contractors using standard avian point count and call-back surveys at pre-selected sites between June 14-16th, 2021 (Photos 10 and 11). A summary of the results can be found below. Detailed description of methods, maps, and results of the bird species of conservation concern survey can be found in the technical report included in Appendix E.

Golden-winged warbler habitat surveys were conducted by qualified contractors using standardized vegetation surveys at pre-selected sites from August 4-7th, 2021 (Photo 10). A summary of the results can be found below. Detailed description of methods, maps, and results of the golden-winged warbler habitat survey can be found in the vegetation technical report included in Appendix A.

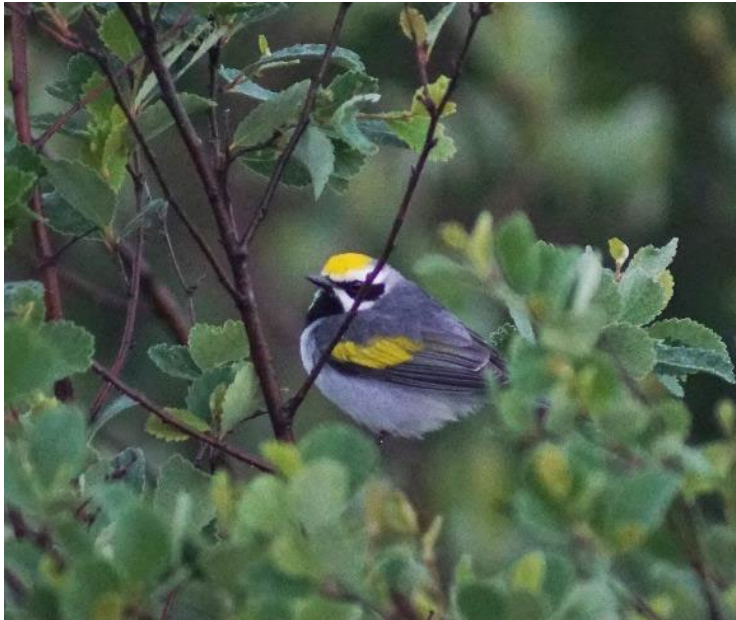
Photo 11 A golden-winged warbler (*Vermivora chrysoptera*) at a monitoring site on MMTP.

The EIS predicted small, low magnitude environmental effects on golden-winged warblers. Post-construction monitoring for golden-winged warblers has shown no effect of construction and installation of the transmission line on golden-winged warbler density, and no unanticipated local population effects were observed. In addition, no least bittern or short-eared owls were observed.

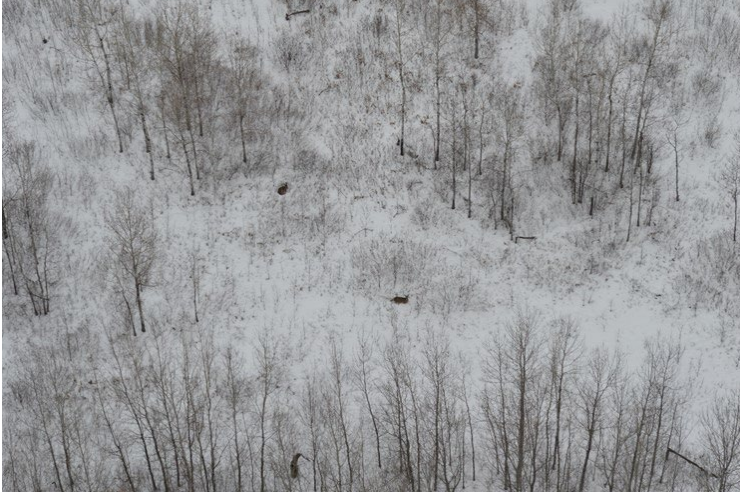
Photo 12 White-tailed deer (*Odocoileus virginianus*) observed during an aerial survey.

Distribution and occurrence mapping surveys for mammals was conducted by a qualified contractor using a standardized aerial survey between March 8-10th, 2022. This survey was conducted by trained observers from a helicopter under appropriate snow conditions to identify and record the abundance and location of mammals (Photo 12). Detailed description of methods, maps, and results of distribution and occurrence mapping survey can be found in Appendix F.

The distribution and relative abundance of deer densities in the 2020 construction phase and 2022 operation phases matched patterns during pre-construction (2017-2018) and support hypotheses that null effects have been observed during the construction and operation periods relative to ungulate density, distribution, and mortality. Observations of predators have not illustrated any detectable changes in densities or occurrence from the pre and postconstruction period. There was no detections of moose or elk during 2021.
